# Seagrass Habitat of Cairns Harbour and Trinity Inlet: Annual Monitoring Report 2024

April 2025 | Report No. 25/07

Centre for Tropical Water & Aquatic Ecosystem Research (TropWATER) James Cook University

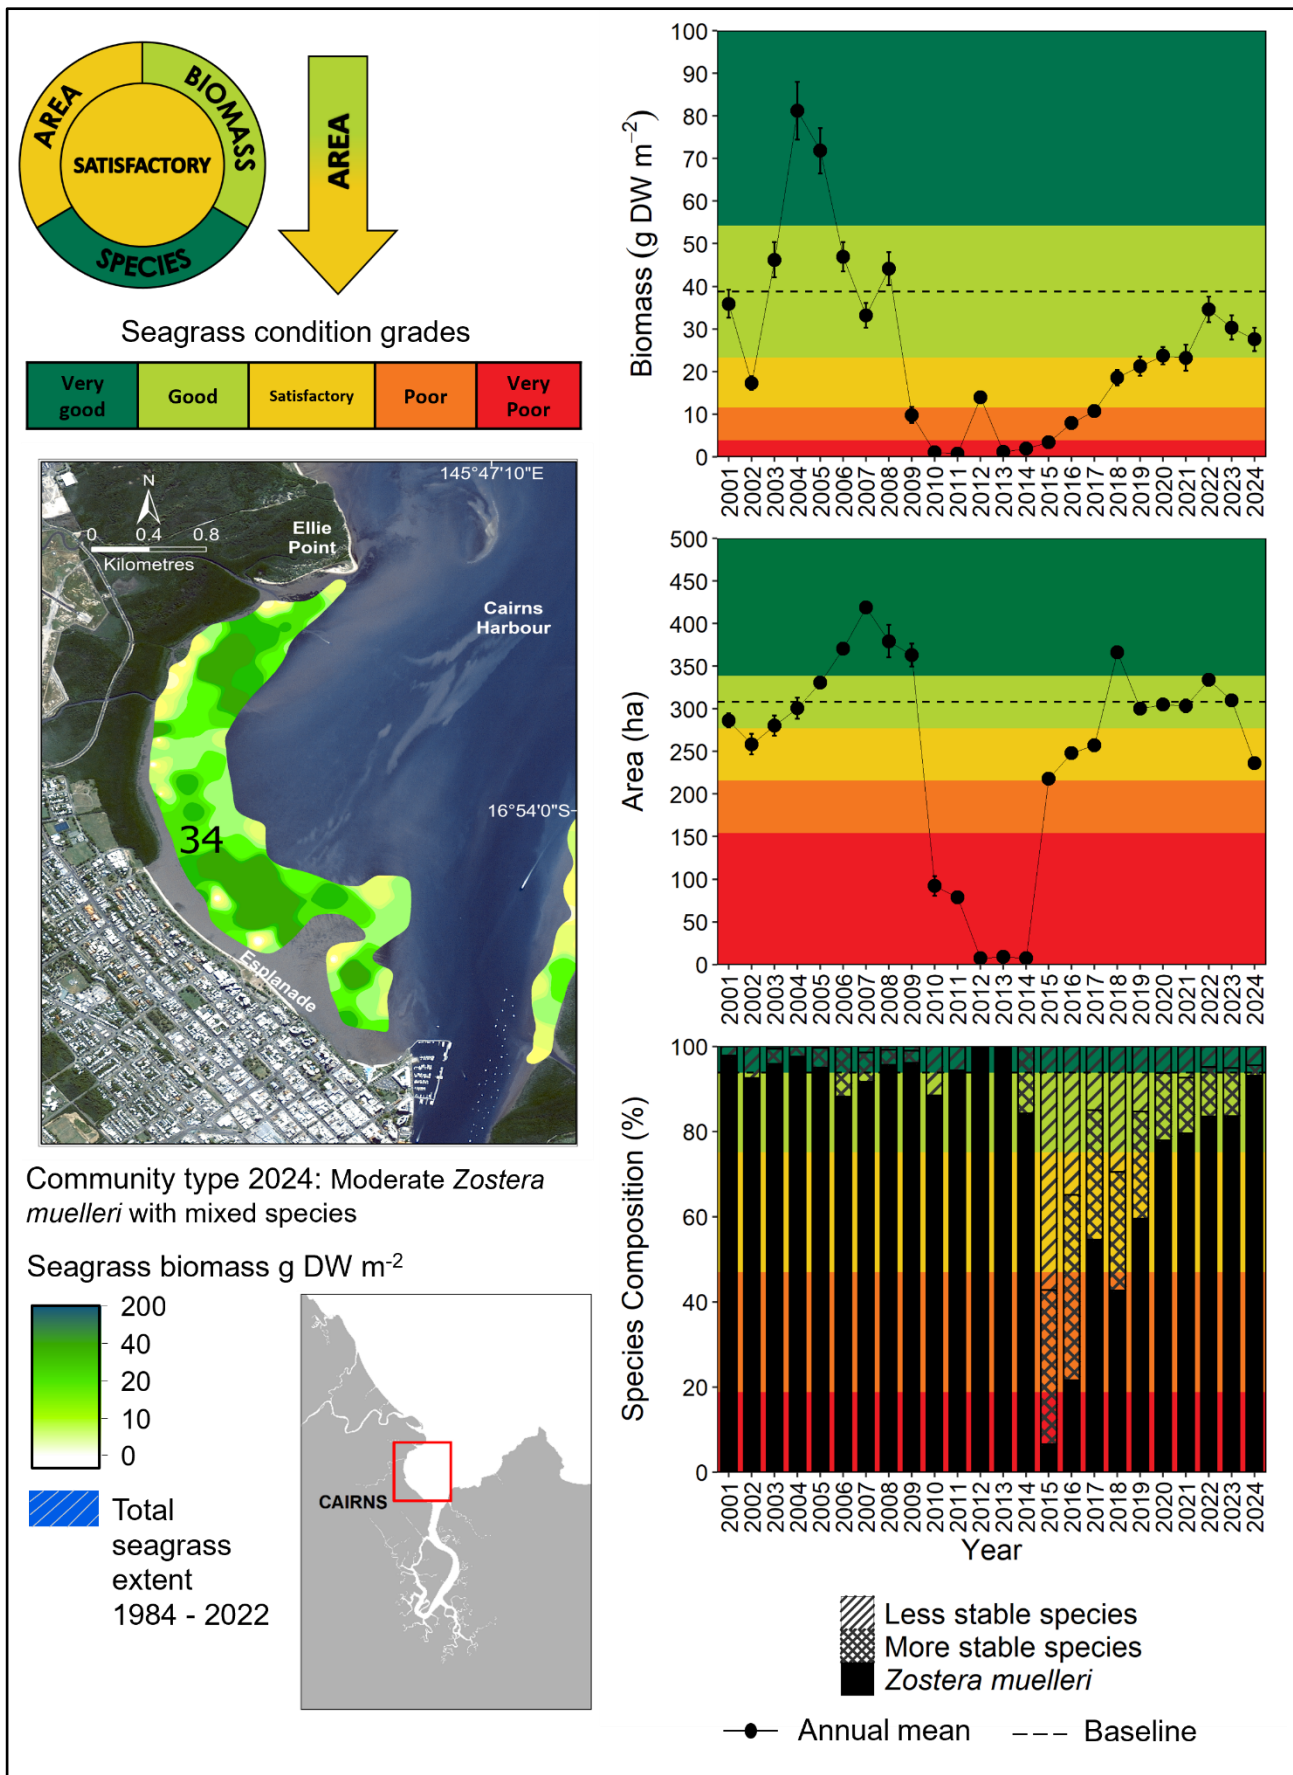
The Esplanade meadow (34) was in a satisfactory overall condition in 2024, a decline from a good condition the previous year (Figure 13 & 19). While the condition indicators of biomass and species composition remained the same as the previous year, there was a decline in area, particularly in the deeper offshore edge of the meadow, which was the main driver behind the condition downgrade (Table 5; Figure 13). Biomass remained in a good condition at  $27.6 \pm 2.7$  g DW m<sup>-2</sup> and was 28% below the long-term average of 38 g DW m<sup>-2</sup> (Figure 13). This meadow is categorised as a moderate density *Z. muelleri* meadow made up of continuous cover of seagrass (Figure 10A) with seagrass biomass ‘hotspots’ more widespread across the meadow now compared to previous years (Figure 19). In 2024, the species composition of this meadow remained in a very good condition with an increase in the amount of *Z. muelleri* in the meadow making up 93% of the species contribution (Figure 13; Appendix 8.1). The footprint of this meadow declined 23% from the previous year to  $236 \pm 5.8$  ha in 2024 and was below the long-term baseline average (308 ha) (Figure 13 and 19).

**Figure 13.** Changes in biomass, area and species composition for the Esplanade meadow (meadow no. 34) from 2001 – 2024 (biomass error bars = SE; area error bars = “R” reliability estimate).

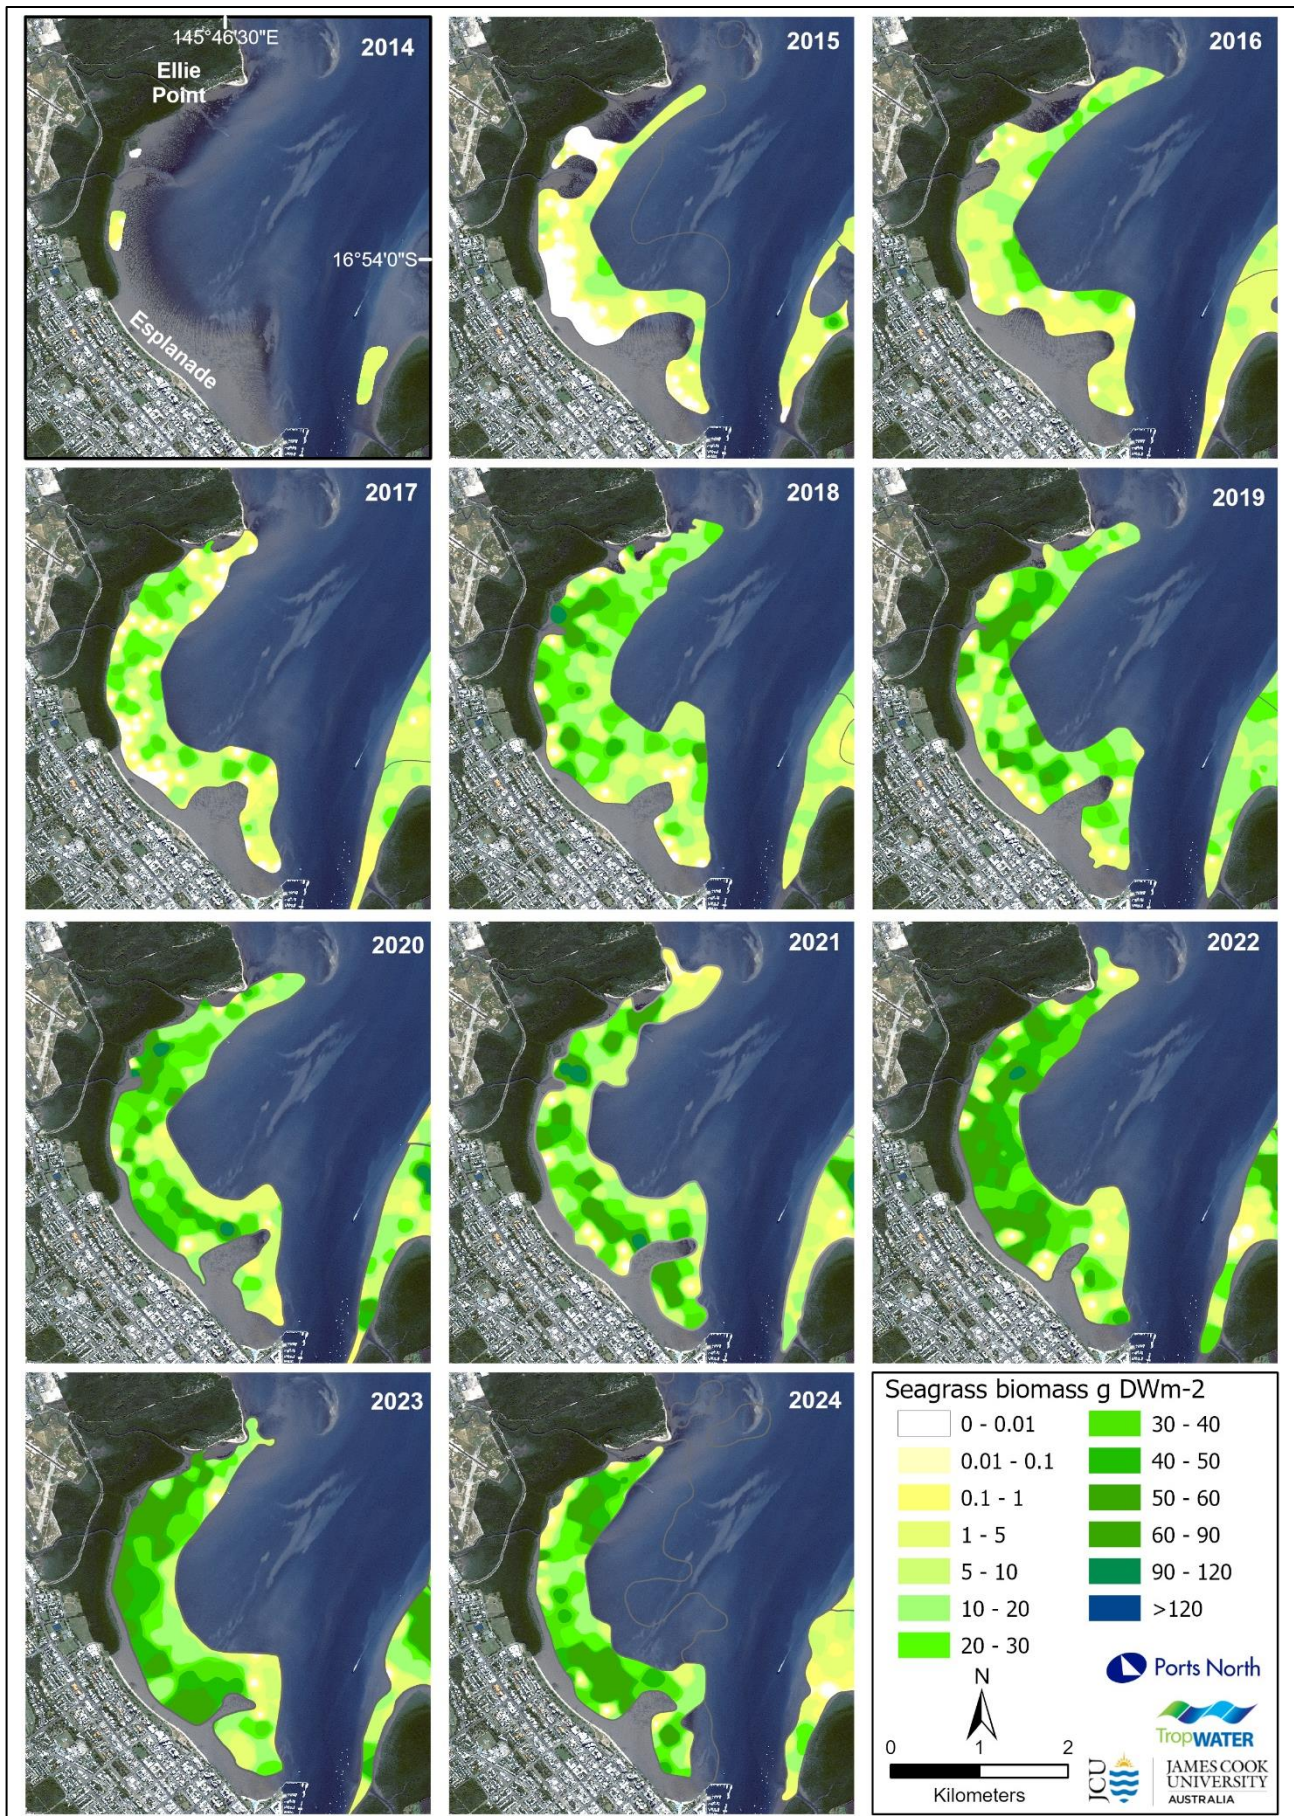
Figure 19. Esplanade to Ellie Point seagrass monitoring meadows from 2014 to 2024.

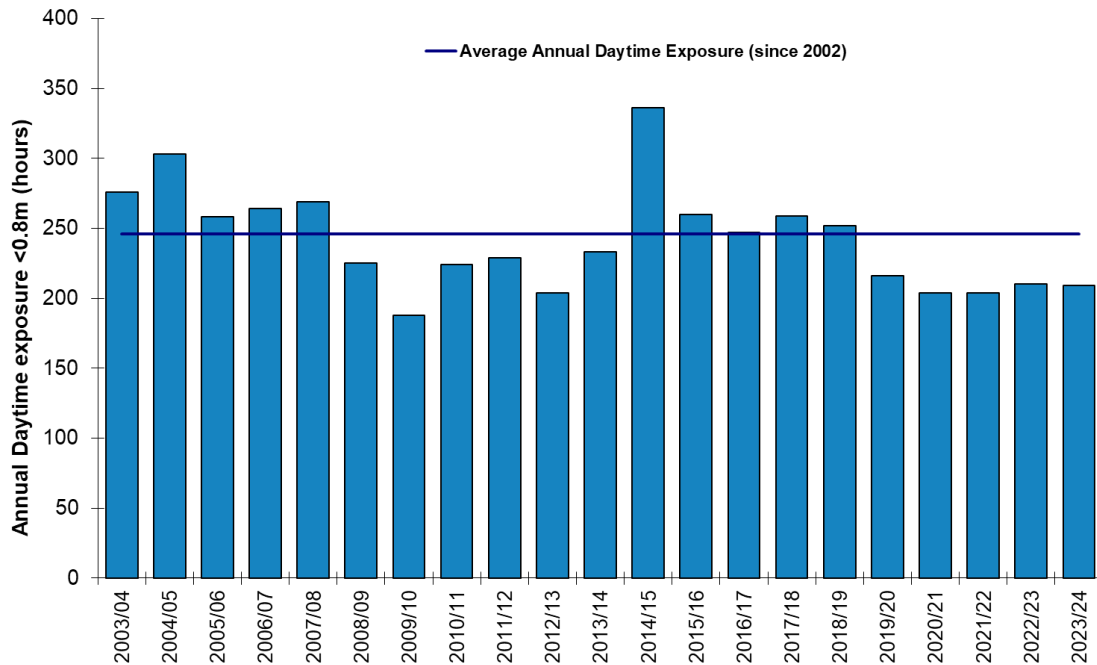
In 2023/2024, intertidal seagrass meadows were exposed to air for a total of 209 hours, marking the fifth consecutive year of below-average annual exposure compared to the long-term average of 246 hours (Figure 30). While monthly exposure exceeded the long-term average in January and June 2024, all other months remained below average (Figure 31).

**Figure 30.** Total annual daytime tidal exposure of seagrass meadows in Cairns Harbour\*; 2003 - 2024. Twelve month year is 12 months prior to survey. Source: Maritime Safety Queensland, 2024. \*Assumes intertidal banks become exposed at a tide height of 0.8m above Lowest Astronomical Tide.
